GMC Classics

TECH EXCHANGE

Quail Springs RV Park — Uvalde, TX
Oct 28–31, 2004

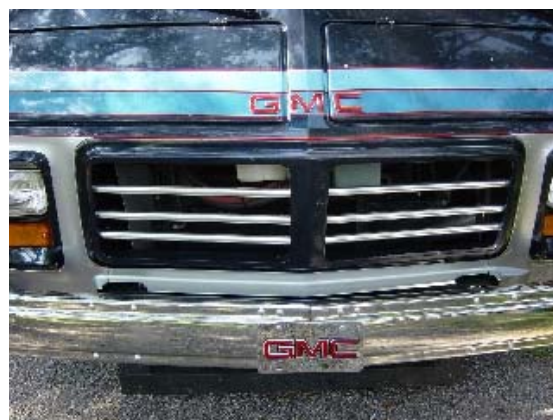
An interesting grille (see picture below): **Ken Rose** modified this grille that was originally designed, fabricated and owned by the late Elam Fayard. Ken added the aluminum bar inserts.

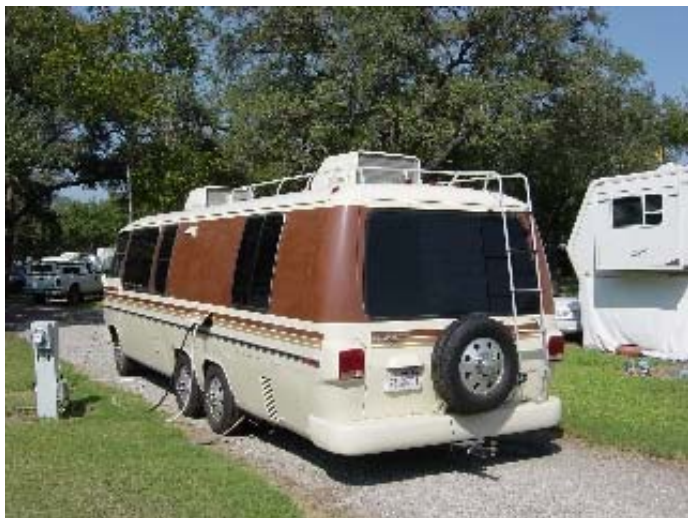
Joyce and Willard Murdock's 1977 28' Stretch (formerly an Eleganza II) was stretched 2' behind the rear wheels; acquired about six months ago.
